Landslide Early Warning

Message ID : LEWM-21-11-2023-1500-66

Update : 66 th update

Validity Period : From 15:00 hrs on 21.11.2023 To 15:00 hrs on 22.11.2023

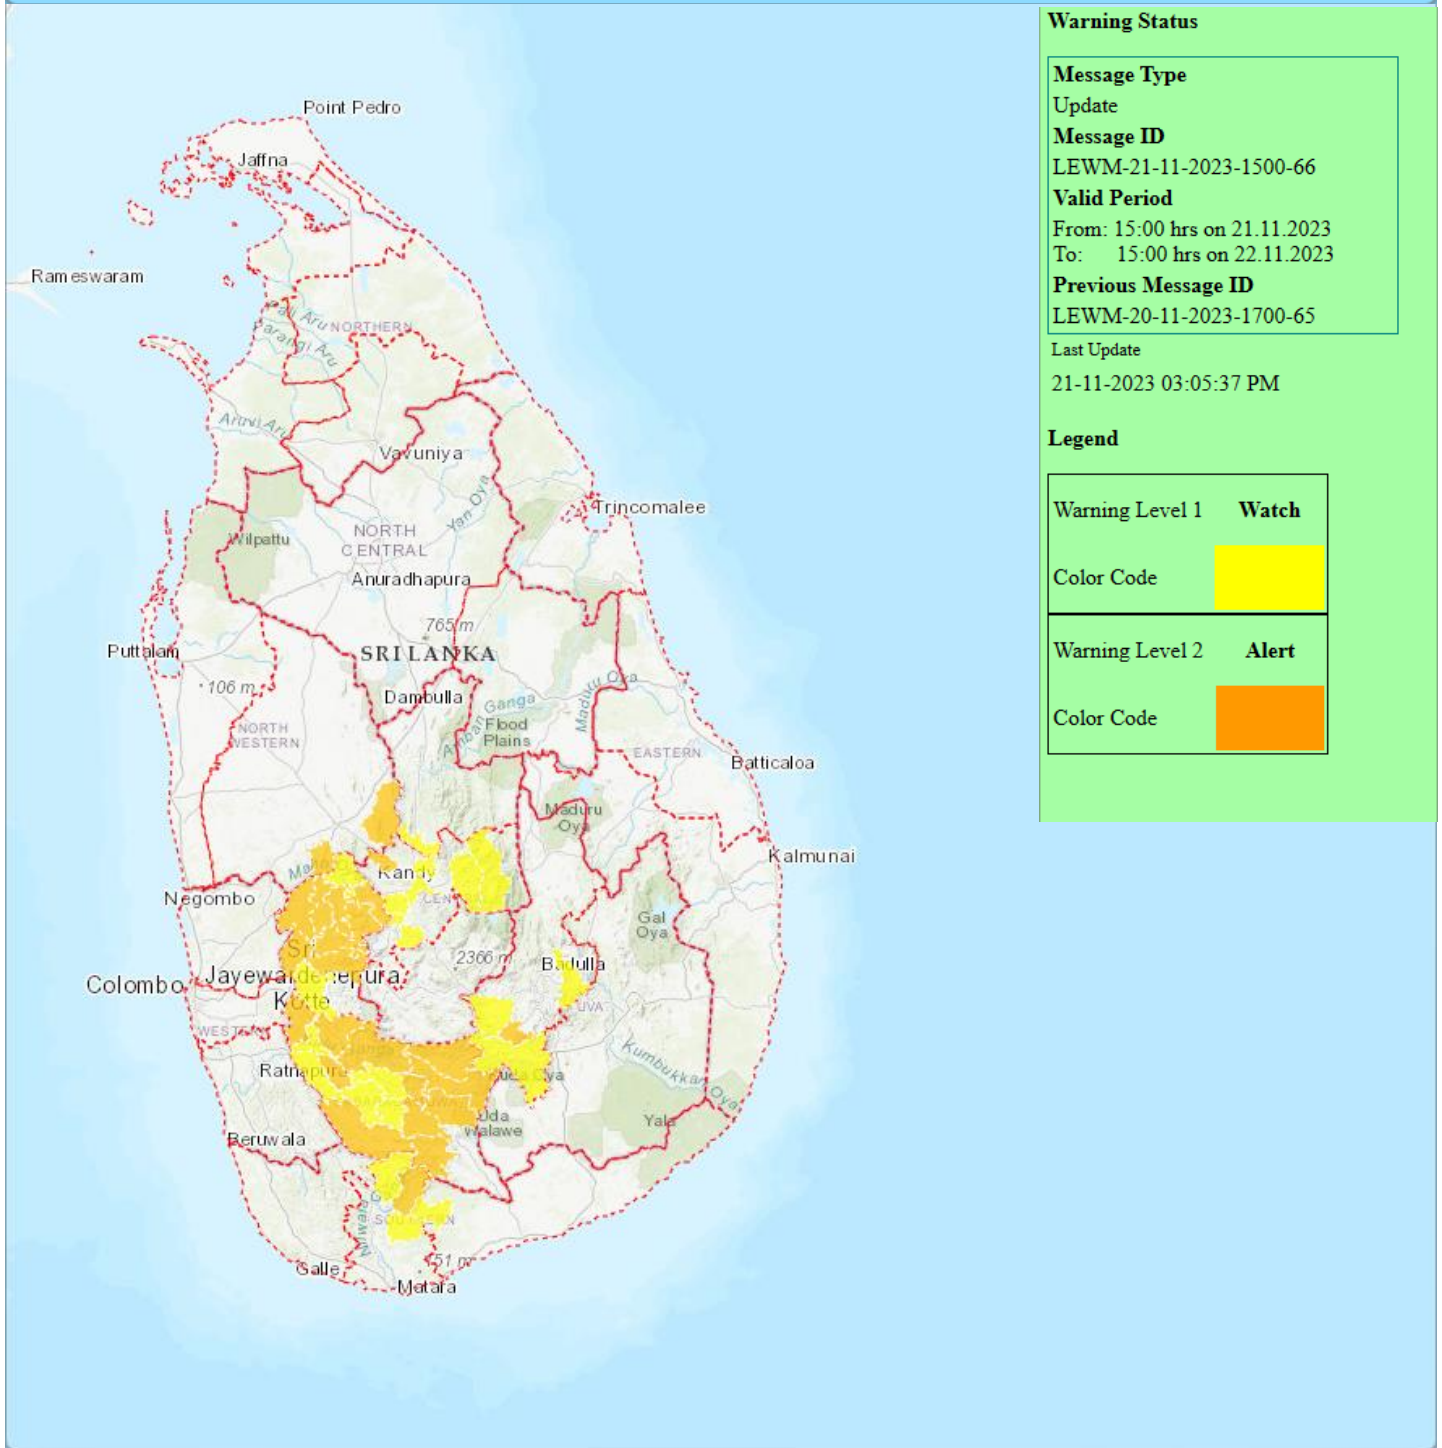
Automated Landslide Early Warning Map

Message Type
Update
Message ID
LEWM-21-11-2023-1500-66
Valid Period
From: 15:00 hrs on 21.11.2023
To: 15:00 hrs on 22.11.2023
Previous Message ID
LEWM-20-11-2023-1700-65
